NASA Technical Memorandum 103620

# Tensile Deformation Damage in SiC Reinforced Ti-15V-3Cr-3Al-3Sn

Bradley A. Lerch and James F. Saltsman  
*Lewis Research Center*  
*Cleveland, Ohio*

April 1991

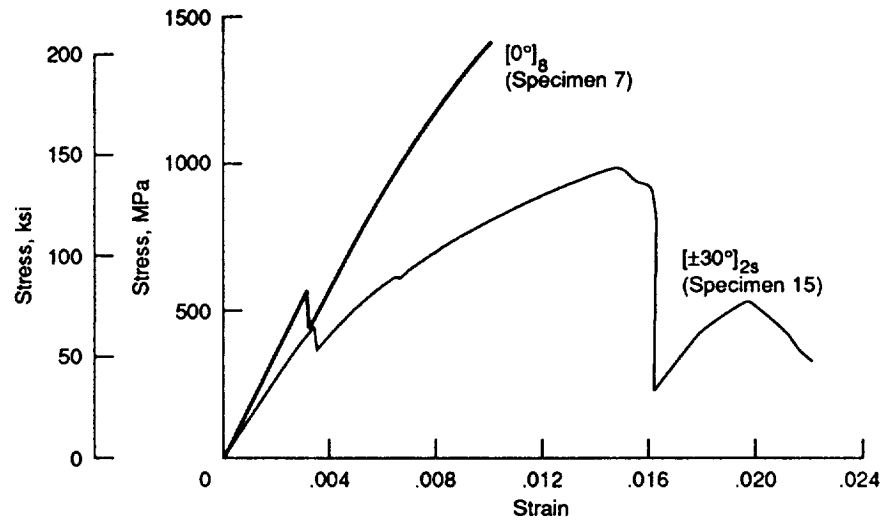
During testing of some specimens, discontinuous stress-strain behavior was observed (fig. 8). At the lower strains, the sudden load drop was accompanied by an audible click. This behavior was observed primarily at room temperature for some of the  $[0^\circ]_8$  and  $[\pm 30^\circ]_{2s}$  layups that were tested as 10.2-cm (4-in.) long samples. We do not know why the shorter specimen length was more prone to this behavior. Metallographic examination of these specimens from tests which were continued to failure, and of specimens from tests interrupted after the load drop failed to reveal the cause for this behavior.

Other discontinuities in the tensile curves were occasionally observed near final fracture (fig. 8,  $[\pm 30^\circ]_{2s}$  curve). This behavior was only observed in room temperature tests for the  $[\pm 30^\circ]_{2s}$  specimens. Its cause is unknown but is believed to be due to the propagation and arrest of cracks.

Another disadvantage of the 10.2-cm-long specimens is that they are prone to sudden load drops (fig. 8). It is possible that these load drops, and the audible click associated with them, were caused by partial debonding of the tab from the specimen. This debonding may have been induced by the stress concentration in the tab region.

Figure 8.—Room temperature tensile curves showing discontinuities.

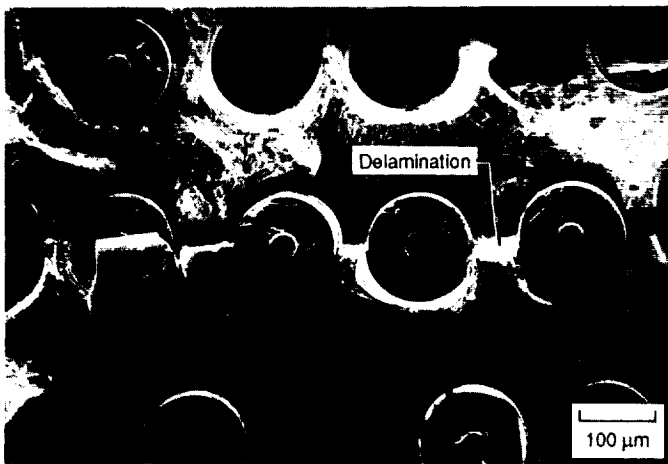
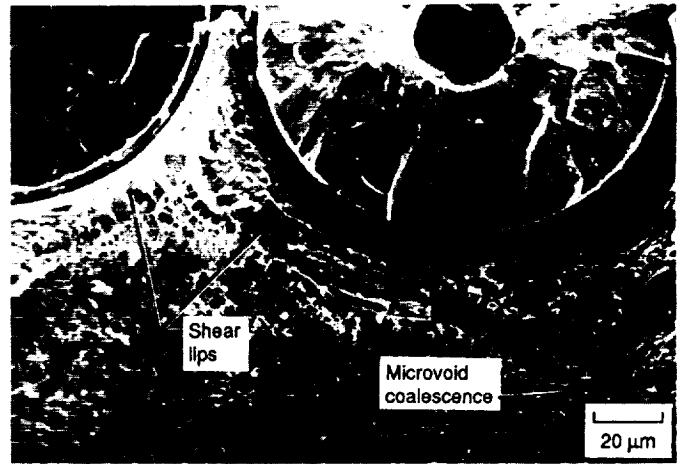
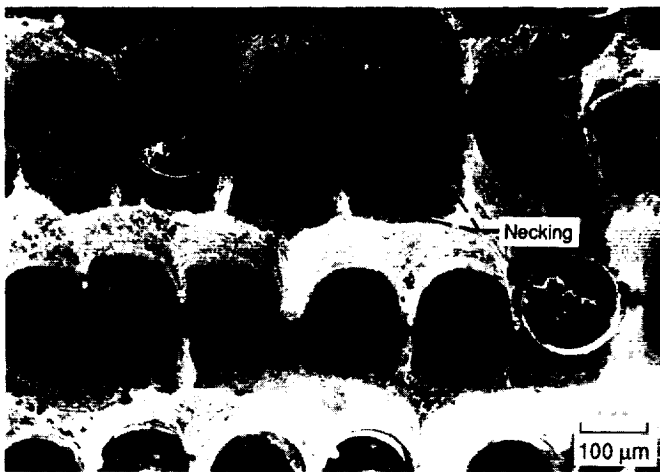
Figure 15.—Fractographs of  $[0^\circ]_8$  specimens.

$[0^\circ]_8$  Layups. - The fracture surfaces obtained during both room temperature and  $427^\circ\text{C}$  were macroscopically flat. The fiber pullout observed left fibers extending out of the matrix for maximum distances of one to two fiber diameters (fiber diam =  $145\ \mu\text{m}$ ). Delamination occurred in some fiber rows (fig. 15(a)) and in some rows extended across the entire specimen width. Delamination was most prevalent where the fibers were closely spaced. The matrix debonded from the fibers in most areas and contained shear lips which had formed immediately adjacent to the fibers (fig. 15(b)). The largest gaps between the matrix and the fiber were between fiber rows rather than between fibers within a row. The remainder of the matrix failed by tensile overload as indicated by microvoid coalescence (fig. 15(a) and (b)). At  $427^\circ\text{C}$  the matrix flowed more readily as indicated by the necking of the matrix surrounding each fiber (fig. 15(c)). The matrix even necked between fibers within a fiber row, which was not observed at room temperature. The amount of delamination appears to be less at  $427^\circ\text{C}$  although more tests are needed to confirm this.

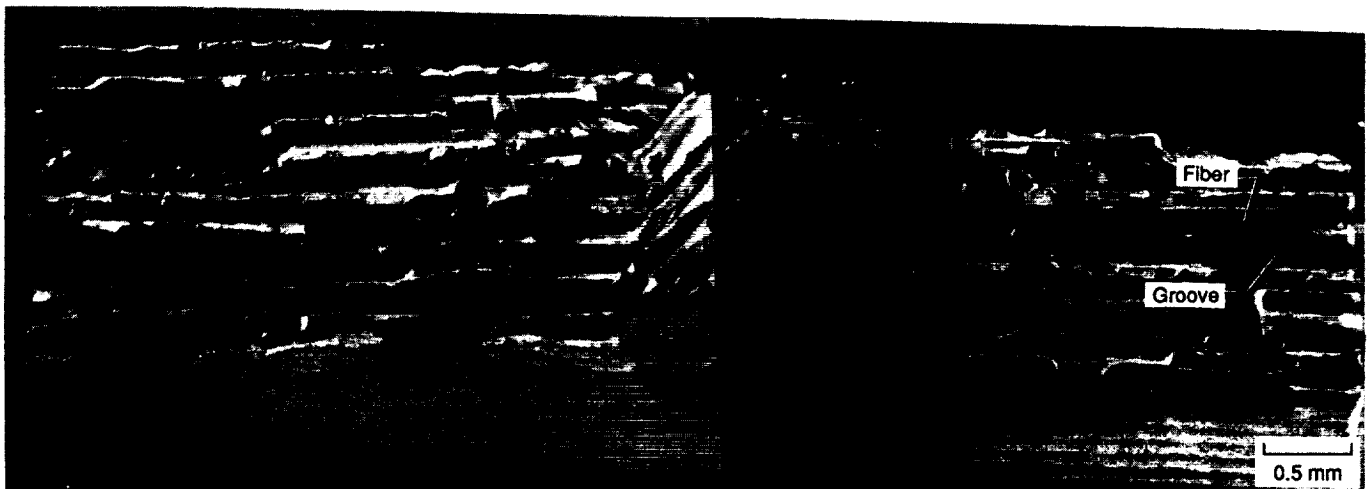
$[90^\circ]_8$  Layups. - Cracking in this fiber layup occurred parallel to the fibers, forming a flat fracture surface (fig. 16). Occasionally, sections of matrix and/or composite were ripped off in chunks. The fibers were either intact or completely missing, and no fiber splitting was observed. If fibers were missing, a groove remained where the fiber once was. The matrix failed similarly to that in the  $[0^\circ]_8$  specimens in that shear lips formed next to the fibers and microvoid coalescence occurred elsewhere (fig. 17(a)). At  $427^\circ\text{C}$  cleavage was an important matrix cracking mechanism as depicted in figure 17(b). More necking of the matrix surrounding the fibers was also observed at  $427^\circ\text{C}$ .

Figure 16.—Fracture surface of  $[90^\circ]_8$  specimen tested at 427 °C.

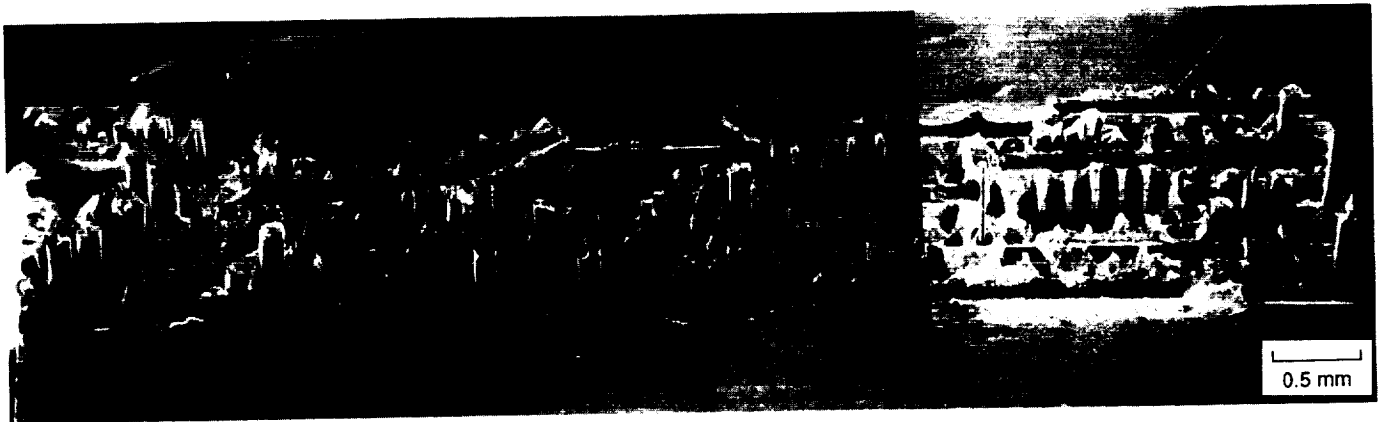
$[0^\circ/90^\circ]_{2s}$  and  $[90^\circ/0^\circ]_{2s}$  Layups. - The  $[0^\circ/90^\circ]_{2s}$  and  $[90^\circ/0^\circ]_{2s}$  specimens behaved similarly and will therefore be discussed together. These specimens' fracture surfaces were identical to the  $[0^\circ]_8$  or  $[90^\circ]_8$  specimen fractures for those plies oriented at  $0^\circ$  or  $90^\circ$ , respectively, to the load axis. The overall fracture surfaces showed evidence of fiber pullout (fig. 18) in the  $0^\circ$ -plies, and missing fibers or fiber-matrix separation in the  $90^\circ$ -plies. The matrix failed through tensile overload as evidenced by microvoid coalescence and shear lips next to the fibers (fig. 19). Some delamination was observed in the  $0^\circ$  plies.

Figure 18.—Fracture surface of  $[90^\circ/0^\circ]_{2s}$  specimen tested at room temperature.

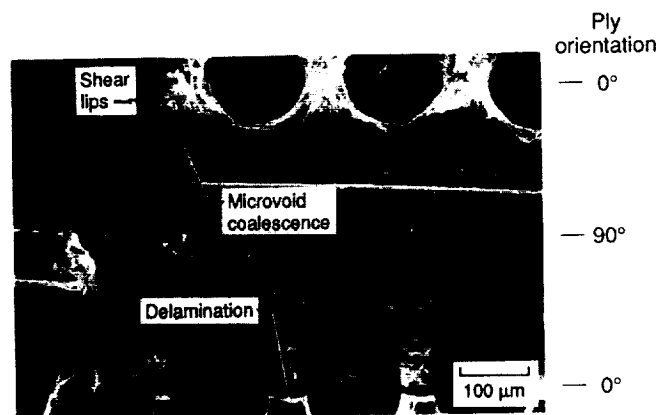
Figure 19.—Fractographs of  $[90^\circ/0^\circ]_{2s}$  specimens tested at room temperature.

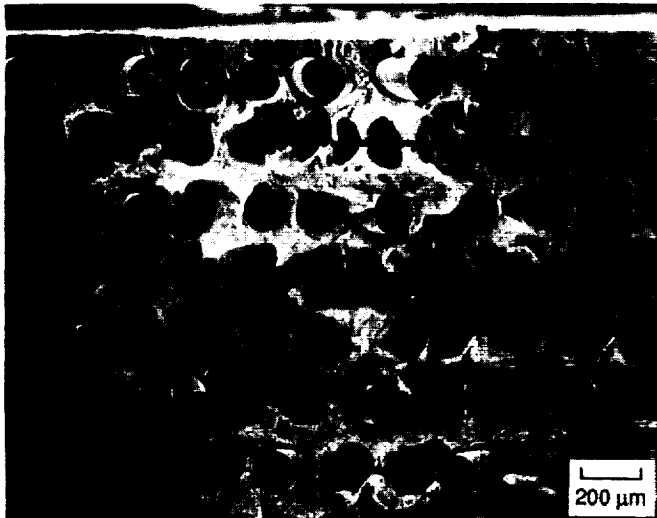
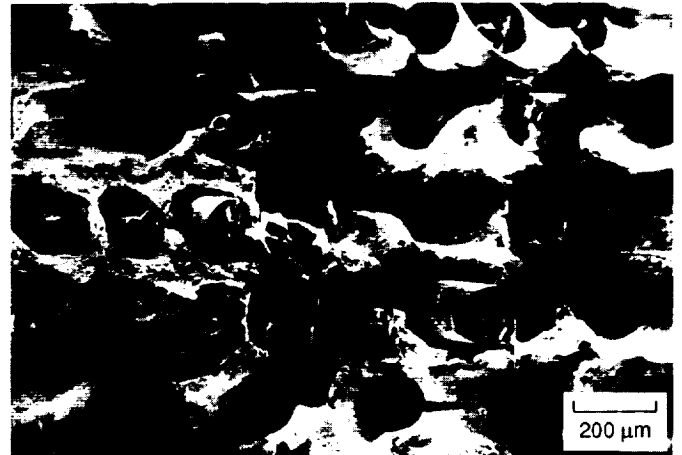
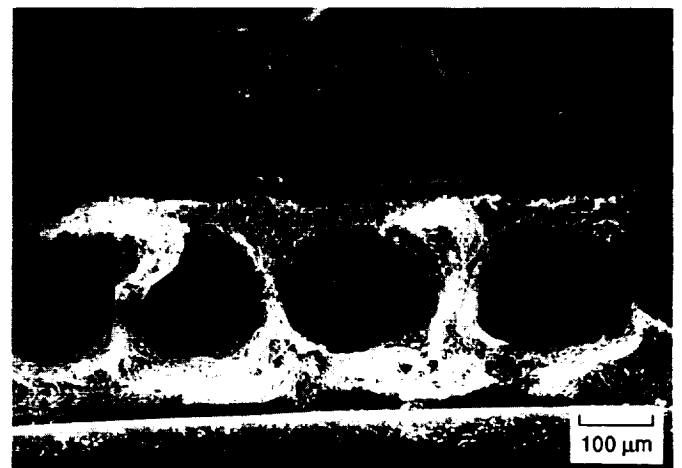
Figure 20.—Fractographs of crossplied material specimens.

$[\pm 30^\circ]_{2s}$   $[\pm 45^\circ]_{2s}$   $[\pm 60^\circ]_{2s}$  Layups. - Examination of these fracture surfaces revealed relatively little additional information. In general, microvoid coalescence and shear lips were observed in the matrix. More matrix ductility was observed at  $427^\circ\text{C}$ , as indicated by increased amounts of necking. Also, some cleavage failure was observed at the high temperature. As the fiber angle increased with relationship to the load axis, larger lengths of

fibers were observed protruding from the fracture (fig. 20(a) to (c)). This is not to say that the fiber pullout length increased, but rather that certain plies were oriented such that they behaved similar to the  $[90^\circ]_8$  specimens wherein long lengths of fibers (or grooves) debonded from the matrix. Also, the fracture surfaces resembled the  $[0^\circ]_8$  specimens at the lower fiber angles (i.e.,  $[\pm 30^\circ]_{2s}$ ) and approached the appearance of the  $[0^\circ/90^\circ]_{2s}$  specimens as the angle increased (i.e.,  $[\pm 45^\circ]_{2s}$  or  $[\pm 60^\circ]_{2s}$ ).

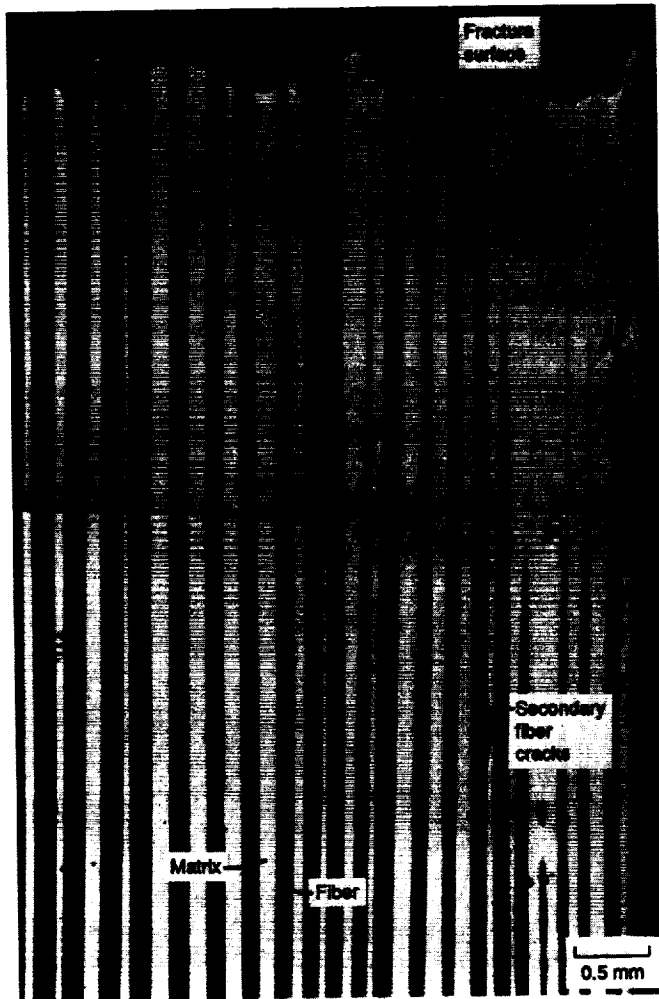
$[0^\circ]_8$  Layups. - Specimens tested to failure at room temperature exhibited extensive fiber cracking and debonding near the fracture surface (fig. 21). These cracks were generally perpendicular to the fiber axis. Away from the fracture surface, few cracks, if any, were observed. Figure 21 also shows a group of secondary fiber cracks in the second ply,  $\approx 5$  mm below the fracture surface. These cracks occurred in the area of a titanium wire and are better observed in the etched specimen of figure 22(a). This row of fiber cracks was not observed in the first ply, since the titanium wire did not appear there.

Figure 21.—Face section of second ply of  $[0^\circ]_8$  specimen showing fiber cracks. Specimen tested at room temperature.

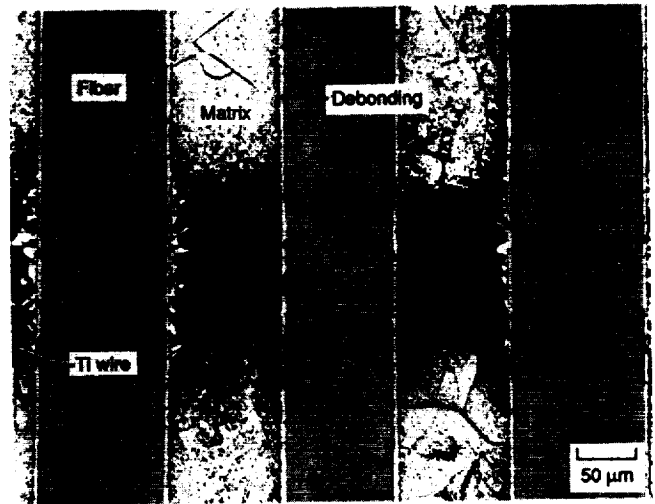
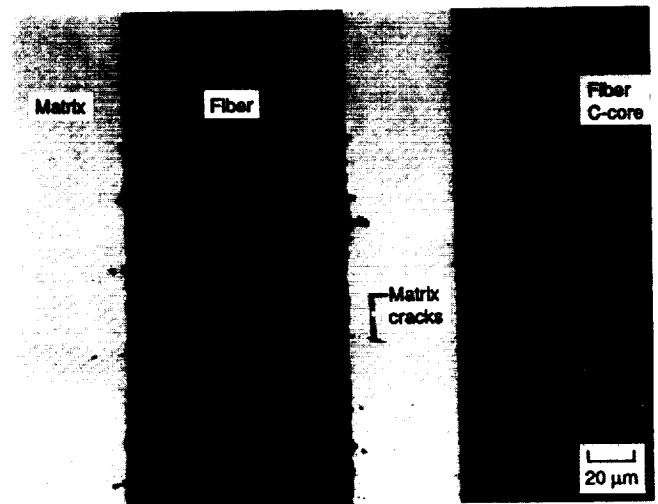
Other than the primary crack (which led to failure), no other matrix cracks were observed. The exceptions were those cracks which sometimes occurred in the matrix in the area of a titanium wire. An example of this is shown in figure 22(b), which is from the same general area of the sample in figure 22(a), but, here, the sample is unetched to permit viewing of the matrix cracks. These cracks were small and rarely propagated to the next fiber.

Figure 22.—Micrograph of  $[0^\circ]_8$  specimen showing fiber cracks near titanium wire weave. Specimen tested at room temperature.

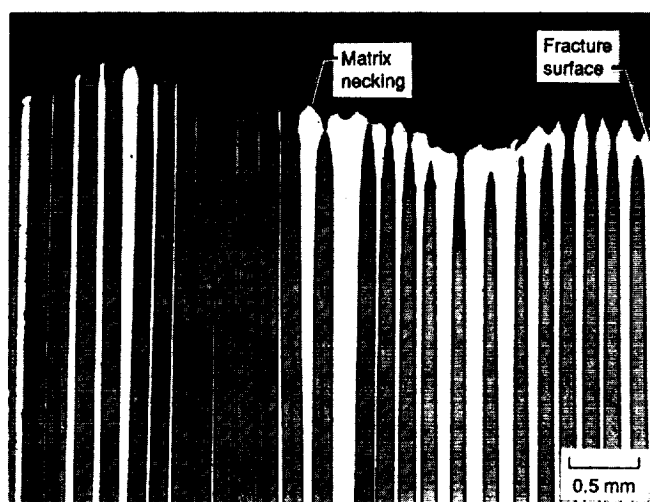
Examination of specimens tested at  $427^\circ\text{C}$  showed an increase in matrix ductility at this temperature as evidenced by matrix necking on the fracture surface (fig. 23). This behavior was not observed in specimens tested at room temperature (compare with figs. 21 and 23). The specimens tested at  $427^\circ\text{C}$  also showed extensive fiber cracking and debonding near the fracture surface and little or no matrix cracking. More fiber cracks were observed away from the fracture surface but these cracks could have been due to specimen to specimen variations and not necessarily to test temperature. One unique observation from the  $427^\circ\text{C}$  test is shown in figure 24. In the through-the-thickness section shown the specimen has necked at the fracture surface. As a result fibers cracked extensively, and the fibers in the outer most plies bent toward the center of the specimen. This necking was not observed in the width nor in any orientation tested at room temperature.

Figure 23.—Face section of  $[0^\circ]_g$  specimen tested at 427 °C.

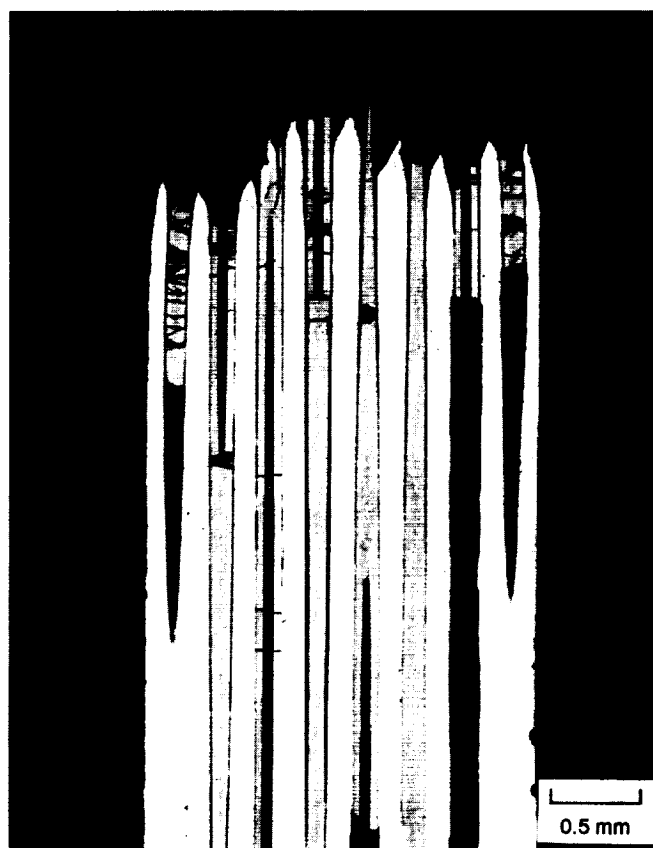
Figure 24.—Through-the-thickness section of  $[0^\circ]_g$  specimen showing reduction of area at fracture surface. Specimen tested at 427 °C.

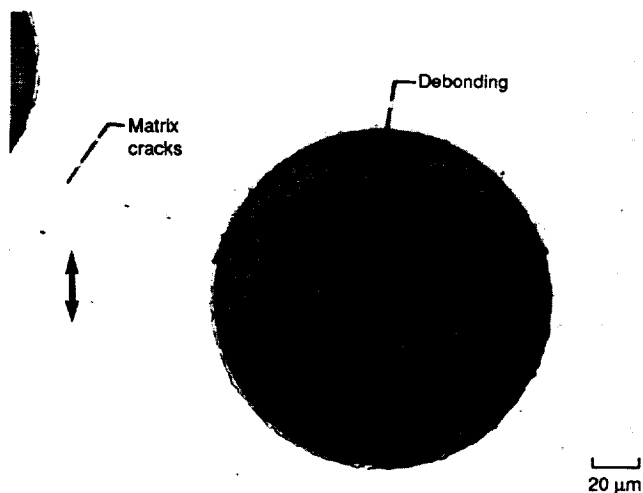
$[90^\circ]_8$  Layups. - Examination of the fracture surfaces showed no difference between those specimens tested at room temperature and those at 427 °C. Other than the primary crack, few matrix cracks, if any, were observed. Figure 25 is a through-the-thickness section showing matrix cracks emanating radially from a debonded fiber. Most fibers were debonded in these specimens. Examination of the first fiber row (fig. 26) shows extensive fiber cracking and splitting only near the fracture surface, which suggests that there was some bending moment, perhaps due to the final fracture.

Figure 25.—Through-the-thickness section of  $[90^\circ]_g$  specimen showing matrix radial cracks and debonding. Specimen tested at 427 °C. Double pointed arrow indicates loading direction.

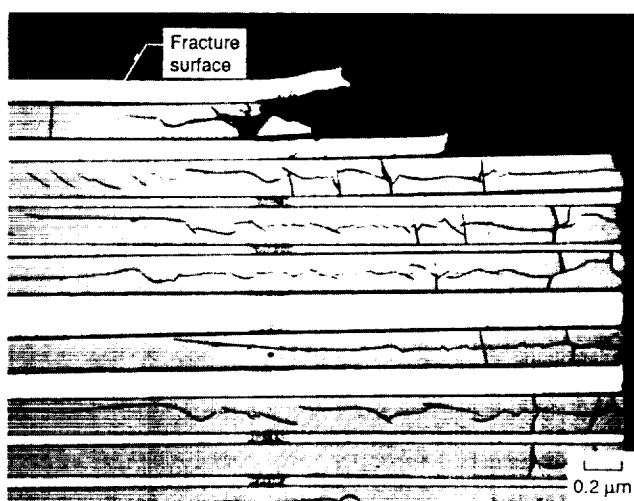
Figure 26.—Face section of  $[90^\circ]_g$  specimen tested at room temperature.

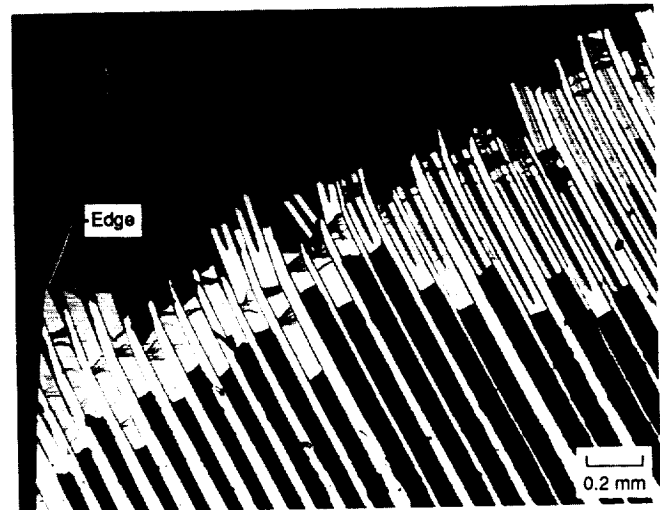
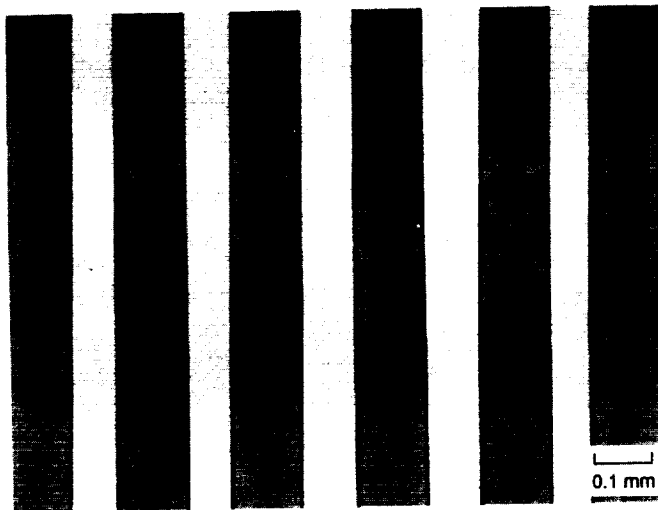
The 90° plies exhibited deformation similar to the unidirectional,  $[90^\circ]_8$  specimens. Fiber cracks and splitting were observed near the fracture surface and at the edges of the specimen. Debonding was also observed along most fibers. The 0° plies contained extensive fiber cracking near the fracture surface. However, unlike the unidirectional  $[0^\circ]_8$  specimens, the 0° plies in this layup also contained fiber cracks remote from the fracture surface (fig. 27). These cracks were not randomly spaced, but were located in groups perpendicular to the fiber axis. As with the 90° plies, few matrix cracks were observed, even in areas which contained fiber cracks. Debonding was also observed in the 0° plies and to a much greater extent than was seen in the unidirectional  $[0^\circ]_8$  material.

Figure 27.—Face section of third ply of  $[0^\circ/90^\circ]_{2s}$  specimen showing fiber cracks far from fracture surface. Specimen tested at room temperature. Double pointed arrow indicates loading direction.

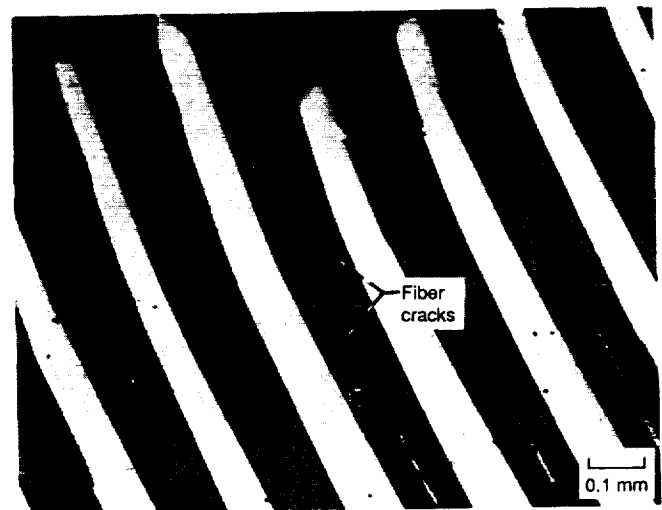
$[\pm 30^\circ]_{2s}$  Layups. - The fracture profile in the first ply is shown in figure 28(a). The fibers, as well as the matrix slivers between the fibers, have rotated as if to align themselves with the load axis. Extensive fiber cracking occurred near the fracture surface, with less occurring away from it. Fiber cracks initiated on one side of the fiber (fig. 28(b)). Some of these cracks did not propagate completely across the fiber diameter. Debonding was also observed along most fibers. Matrix cracks were rarely observed, except when associated with a leach pit, as depicted in figure 29. These pits were observed frequently on the crossplied material and reportedly result from the manufacturing process. The hot isostatic press (HIP) can after consolidation is removed using an acid solution. If not done correctly, the solution can etch the composite matrix leaving a pit (fig. 29). In this study these pits usually acted as crack initiators, regardless of fiber orientation. Since there is no way to assess their effect on the mechanical behavior, although it probably degrades properties, they will not be further discussed. It is interesting to note however, that cracks initiating at the tip of a leach pit were always arrested at the first fiber row.

Figure 28.—Face section of  $[\pm 30^\circ]_{2s}$  specimen tested at room temperature. Fiber rotation is accommodated by fiber cracking. Double pointed arrow indicates loading direction.

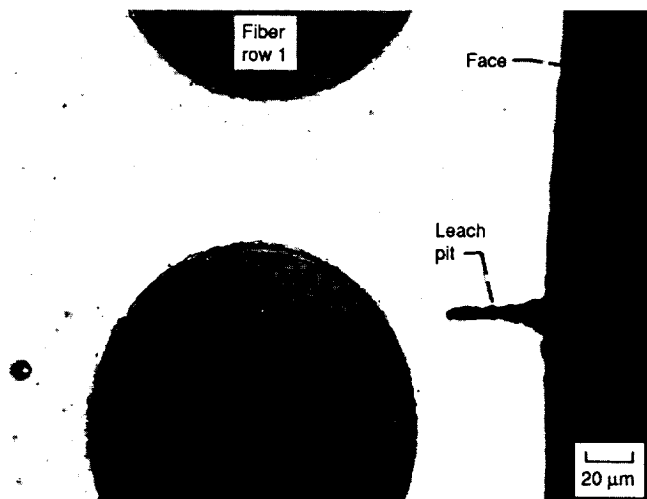
Some matrix cracks were observed, but these were limited to the outer matrix sheet and were always associated with the leach pits (fig. 29). There was also one isolated area in which cracks (a total of five cracks) were found in four fibers. This area was on the edge of the specimen and in the second ply. No other fiber cracks were observed.

Figure 29.—Through-the-thickness section of  $[\pm 30^\circ]_{2s}$  specimen showing leach pit created during manufacturing process.

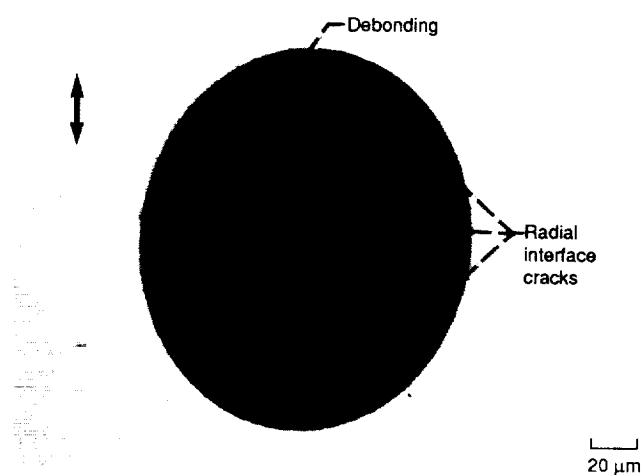
$[\pm 60^\circ]_{2s}$  Layups. - Optical microscopy investigations revealed no differences between specimens tested at room temperature and at 427 °C. The primary fracture followed one set of fibers, and in these plies the damage was similar to that seen in unidirectional,  $[90^\circ]_8$  specimens. Few, if any, matrix cracks were observed. Some fiber cracks perpendicular to the fiber axis were observed, but no longitudinal splitting at the specimen edges was seen, as was the case in the unidirectional,  $[90^\circ]_8$  specimens. Debonding was observed along nearly every fiber. Figure 30 shows a through-the-thickness section showing a debonded fiber. The gap between the interface and the fiber is largest on the ends that are nearly parallel to the thickness of the specimen. The other sides of the fiber, that is those that are parallel to the length of the specimen, contain radial coating cracks, some of which extend into the reaction zone.

Figure 30.—Through-the-thickness section of  $[\pm 60^\circ]_{2s}$  specimen showing interface debonding on upper and lower surfaces and radial interface cracks on left and right surfaces. Double pointed arrow indicates loading direction.

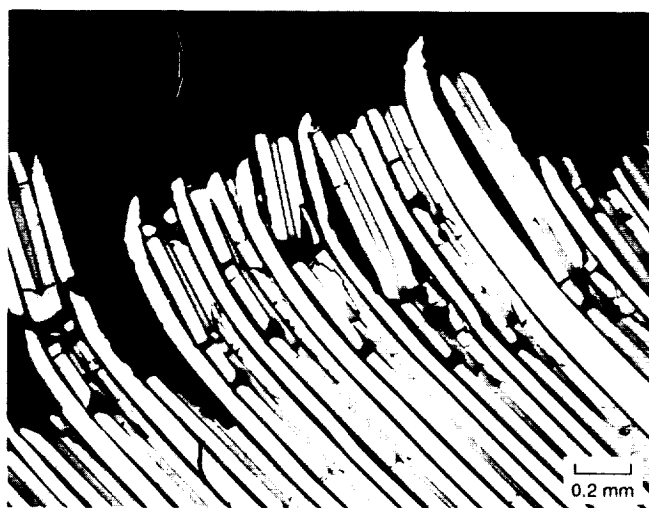
Although the fracture followed one set of fibers, the other set (i.e., the crossplies) were fractured in a manner similar to that of the  $[\pm 30^\circ]_{2s}$  specimens. Figure 31 shows extensive

bending of the fibers and matrix toward the loading axis. Fiber cracks occurred throughout the specimen, and propagated perpendicular to the fiber axis. Near the fracture surface, fiber damage is extensive. Again, nearly every fiber was debonded.

Figure 31.—Face section of  $[\pm 60^\circ]_{2s}$  specimen showing fracture surface. Specimen tested at room temperature. Double pointed arrow indicates loading direction.

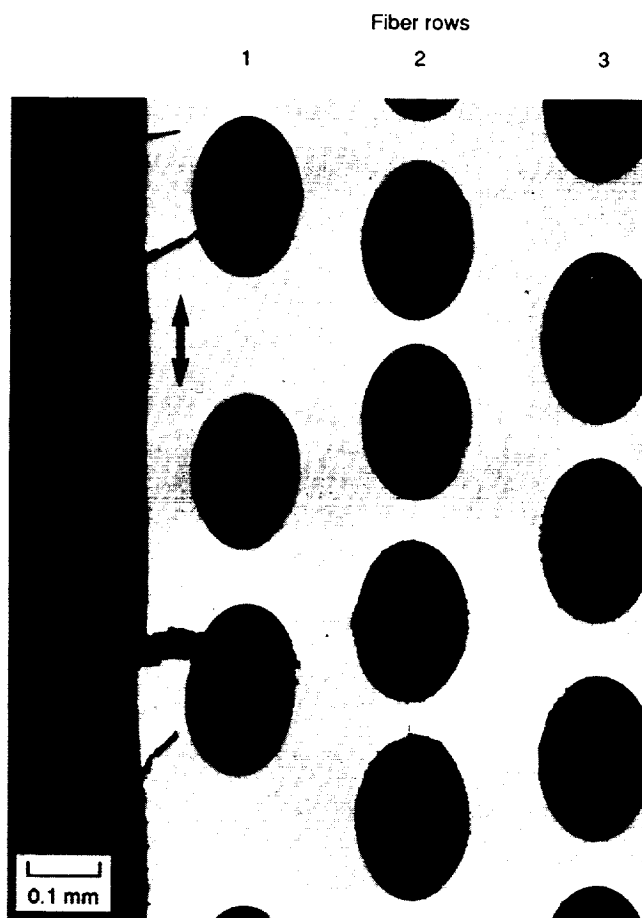
[ $\pm 45^\circ$ ]<sub>2s</sub> Layups. - This orientation contained unique damage modes. Testing of the room temperature specimen was stopped at 4 percent strain. Extensive fiber cracking and debonding had occurred. The fiber cracks were perpendicular to the fiber axis. Some matrix cracking was observed in through-the-thickness sections (fig. 32), and these cracks appeared to initiate on the face. No matrix cracks were observed beyond the first fiber row.

Figure 32.—Through-the-thickness section of  $[\pm 45^\circ]_{2s}$  specimen. Room temperature test interrupted after 4 percent strain. Double pointed arrow indicates loading direction.

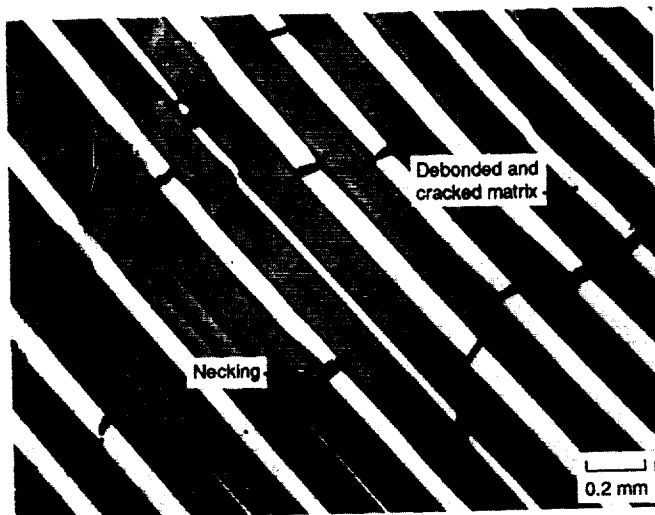
The specimens tested at 427 °C sustained a large amount of damage. Fibers were extensively cracked, even in areas far removed from the fracture surface (fig. 33). The fiber cracks were not always perpendicular to the fiber axis but were bent, approaching a longitudinal direction. Large gaps associated with debonding were also seen. Extensive matrix cracking is also observed in figure 33. The matrix in several areas has necked down and resulted, in some areas, in a 43-percent reduction in area. Figure 34 shows the edge of the specimen at which the matrix has been stretched past the plane of the fiber ends by approximately one fiber diameter. This figure also shows a waviness in the fibers and matrix slivers between fibers which is due to the large amounts of damage.

Figure 33.—Face section of  $[\pm 45^\circ]_{2s}$  specimen pulled to failure at 427 °C. Double pointed arrow indicates loading direction.

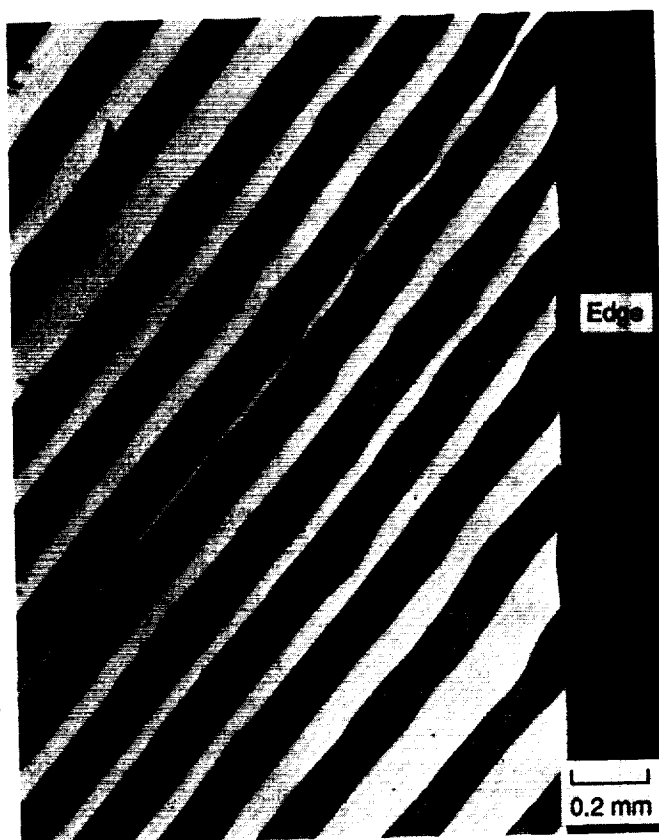
Figure 34.—Face section of  $[\pm 45^\circ]_{2s}$  specimen tested to failure at 427 °C. Double pointed arrow indicates loading direction.

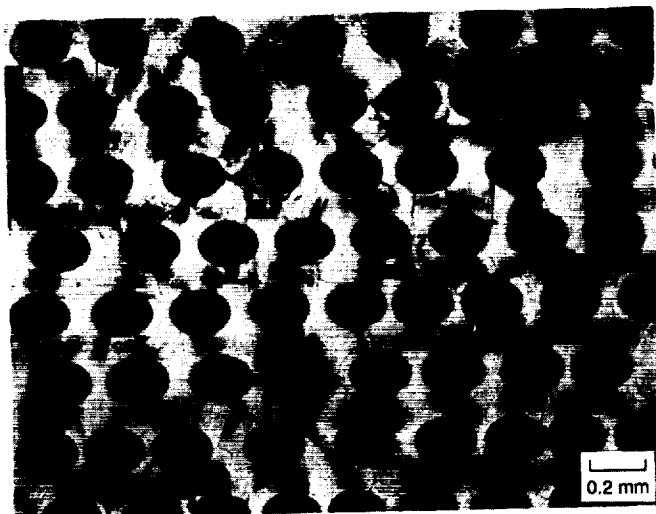
Testing at a slower strain rate of  $10^{-5} \text{ sec}^{-1}$  at 427 °C resulted in observable slip bands in the matrix (fig. 35). Slip could not be resolved in any of the other tested specimens. It is believed that the appearance of these bands is a dynamic strain aging effect caused by the slower straining rates. Thus, the waviness in the stress-strain curve observed in figure 13 is believed to be a consequence of dynamic strain aging.

Figure 35.—Sections of  $[\pm 45^\circ]_{2s}$  specimen showing slip bands. Test temperature, 427 °C; strain rate,  $10^{-5}$ ; etched. Double pointed arrows indicate loading direction.

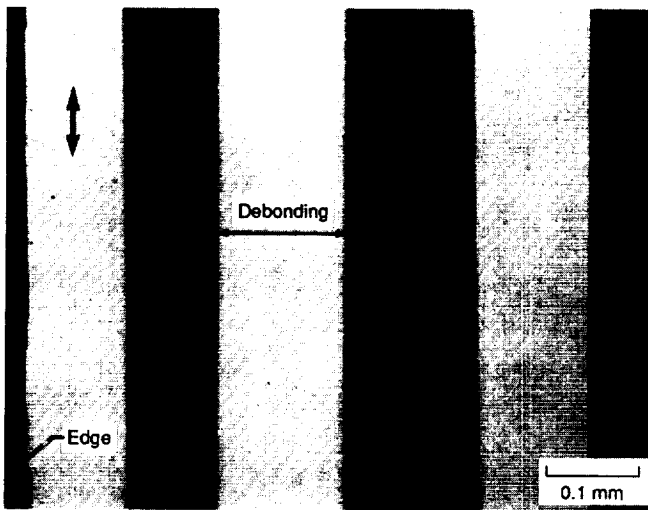
[0°]<sub>8</sub> Layups. - A specimen was interrupted at a longitudinal strain of 0.5 percent which represents the first signs of nonlinearity (point A in fig. 7(a)). No damage was observed in the composite. A second specimen was strained just short of failure (point B in fig. 7(a)) to a longitudinal strain of 0.85 percent. This strain is 94 percent of the average failure strain of 0.90 percent for the [0°]<sub>8</sub> orientation. No matrix or fiber cracks were observed, nor was there any evidence of delamination. However, some debonding was evident (fig. 36).

Figure 36.—Face section of  $[0^\circ]_8$  specimen tested to a strain of 0.85 percent at room temperature. Double pointed arrow indicates loading direction.

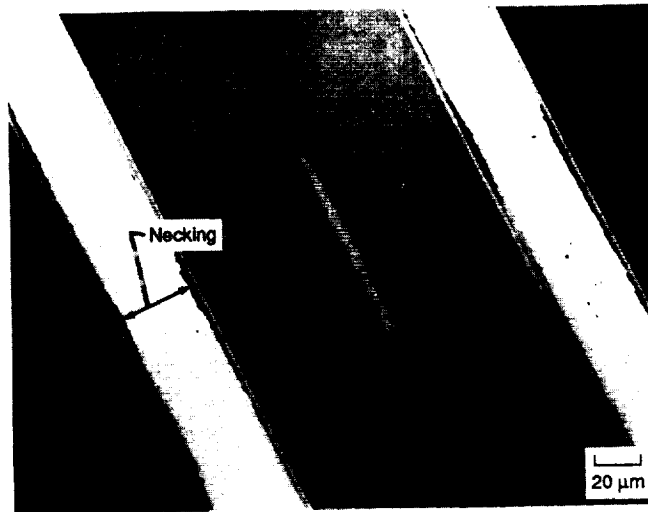
Figure 39.—Face section of  $[\pm 30^\circ]_{2s}$  specimen tested at room temperature to a strain of 0.8 percent. Double pointed arrow indicates loading direction.
